McArthur Island Flood Protection Redesign

Prepared by Hannah Clark

Date: November 11, 2021

MCARTHUR
ISLAND FLOOD
PROTECTION

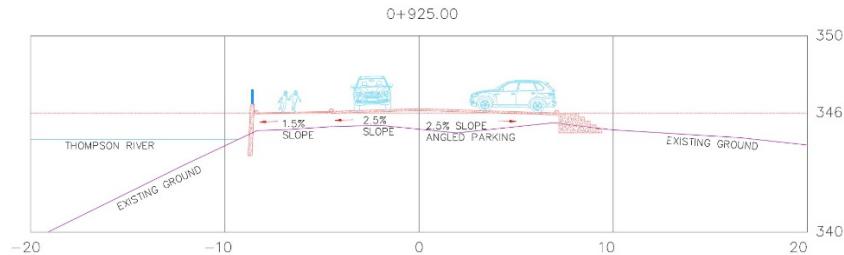
Figure 1: Cross Section of Path, Road, and Angled Parking

In the design, the roadway and multi-use path have undergone an elevation increase of approximately a metre, bringing them to 346m above sea level. This puts the elevation along the river's edge above the 20-year flood plain. When the road was raised, considerations were made as to how the shoulder of that road would integrate down to existing ground. The options are to slope away from the road until existing ground is met, or to put in a retaining wall. Due to the close proximity of the river's edge on the river side of the path, putting in a retaining wall is the best option, as illustrated in Figure 1.

On the park side of the road and path, the goal was to slope the new elevation down to the existing ground. In a couple of sections this wasn't possible, such as at station 0+925 shown as Figure 1. The 10% slope needed would have been too steep for pedestrians to be able to walk down to the soccer fields so a few stairs are needed to get to existing ground. The standard is a maximum 5% slope for a person's ability to walk down it and a lower slope is even better. For other areas of the road, a lower slope was possible and implemented for a comfortable walk to the sports fields, as shown in Figure 2 with a 3% slope and Figure 3 with a 2.5% slope.

Initially, the plan was to put in a natural option for retaining wall, such as an MSE wall, but in a personal interview with Urban Systems' Engineer-in-Training – Water Resources, Cole Becker, it was determined that the river is too turbulent for that to be a long-term solution. A concrete retaining wall will have the strength and durability needed in times of high water.

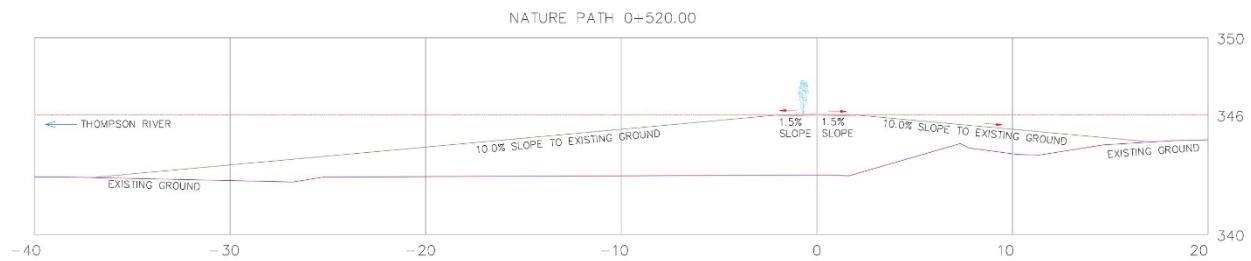
Figure 4: Cross Section of Nature Path

The nature path on the West side of the park does not have the same requirement of a walkable slope on the sides due to the lack of infrastructure beyond the path itself and so a 10% slope to existing ground is what is planned for both sides of the path, as seen in Figure 4, except for when a retaining wall is needed due to the proximity of the river's edge as in Figure 5.

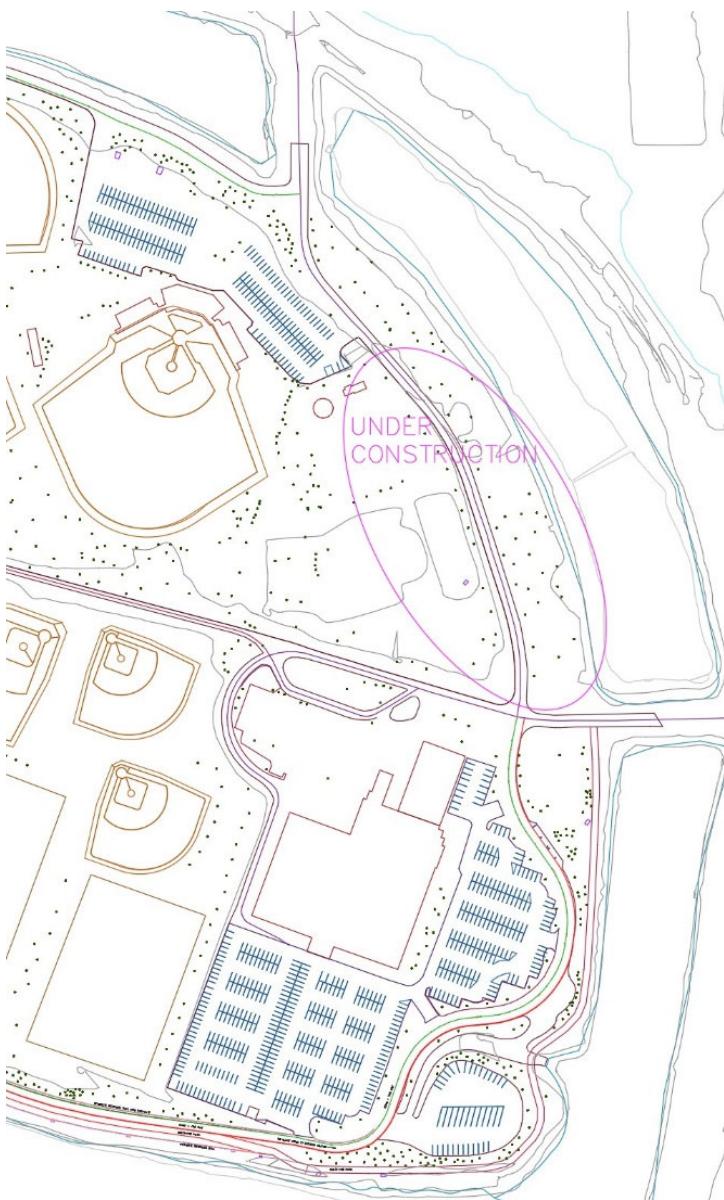
Figure 6: Portion of McArthur Island Under Construction

The elevation was not raised for the roadway or path anywhere along the slough. The elevation in this portion of the park needs to match the elevation of the residential area on the other side of the slough, otherwise the flooding would just occur on that side. The one exception is the section that contains the outdoor exercise equipment. Urban Systems and The City of Kamloops already have a project underway to raise the elevation of the path in that section (shown in Figure 6).

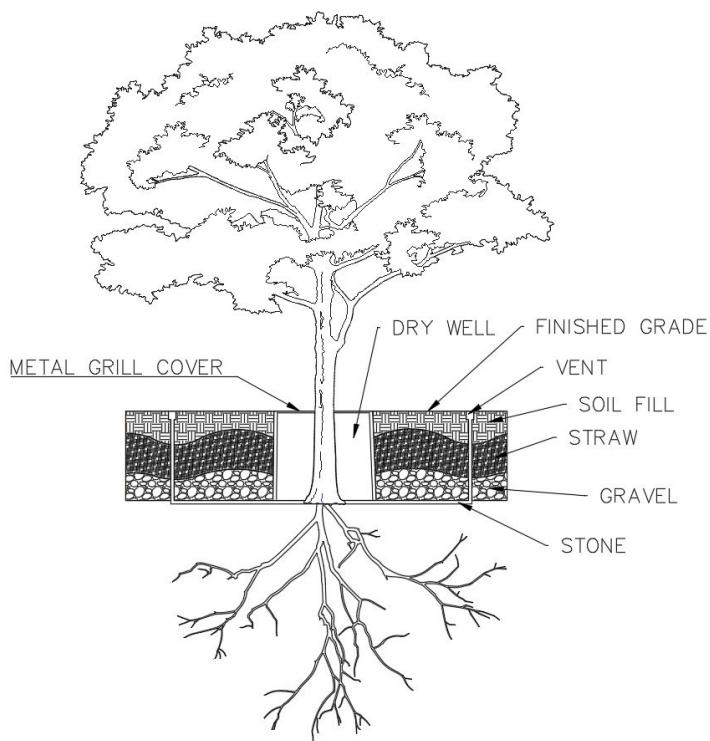
Figure 7: Procedure for Grad Increase of 0.6m or More

As part of the process to raise elevation, existing trees need to be protected from these grade changes. Trees need special consideration to maintain life and health through grade changes. When the grade is elevated, a deep fill technique is employed to ensure the protection of the tree's bark and an aeration system is put in place to keep the roots healthy [11]. These methods are detailed in Figure 7, Figure 8 and Figure 9. When the grade is decreased, the method to maintain tree health involves leaving the original ground from the trunk to the tree's dripline and building steps or a small retaining wall down to the new grade. This case does not occur in this project.

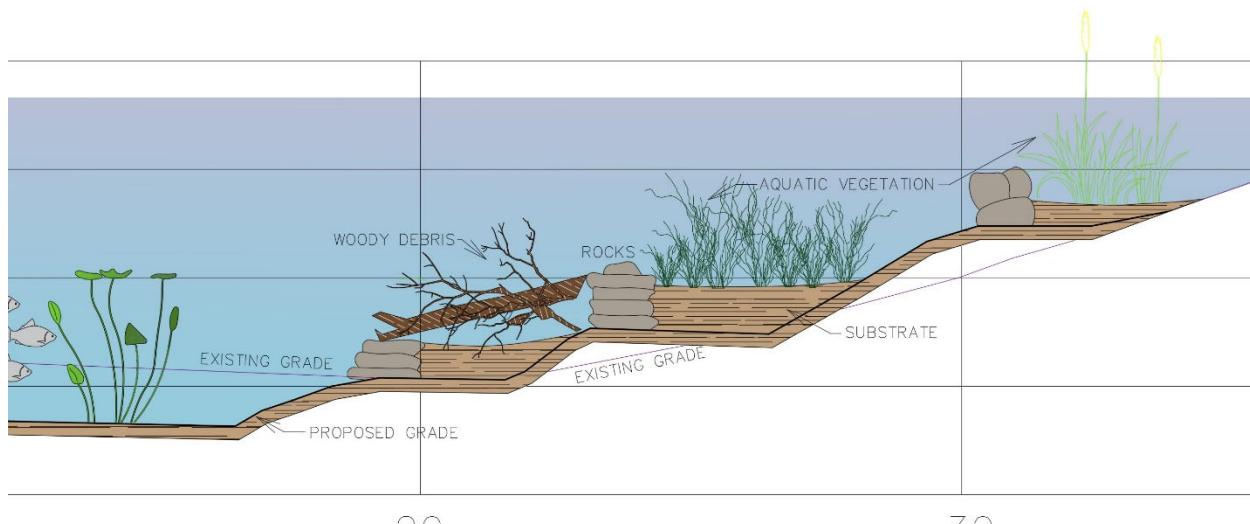
Figure 10: Aquatic Wildlife Habitat Rebuild Detail

As the contribution to regional flood protection after placing a barrier along the riverbank, McArthur Island's slough has been allocated to absorb and store more flood water. The safest time to bar scalp the area is during the season that the slough is dry as most of the living aquatic wildlife has moved to other areas. The slough is to increase in depth by 1.0m. Such a drastic change will create extensive upheaval to wildlife habitats and these need to be rebuilt. Woody debris, rocks, and plants native to the area will be planted to recreate and improve the existing habitats. Also, different levels will be created within the slough to create habitats for the aquatic wildlife that require shallower water for optimum health, see Figure 10.

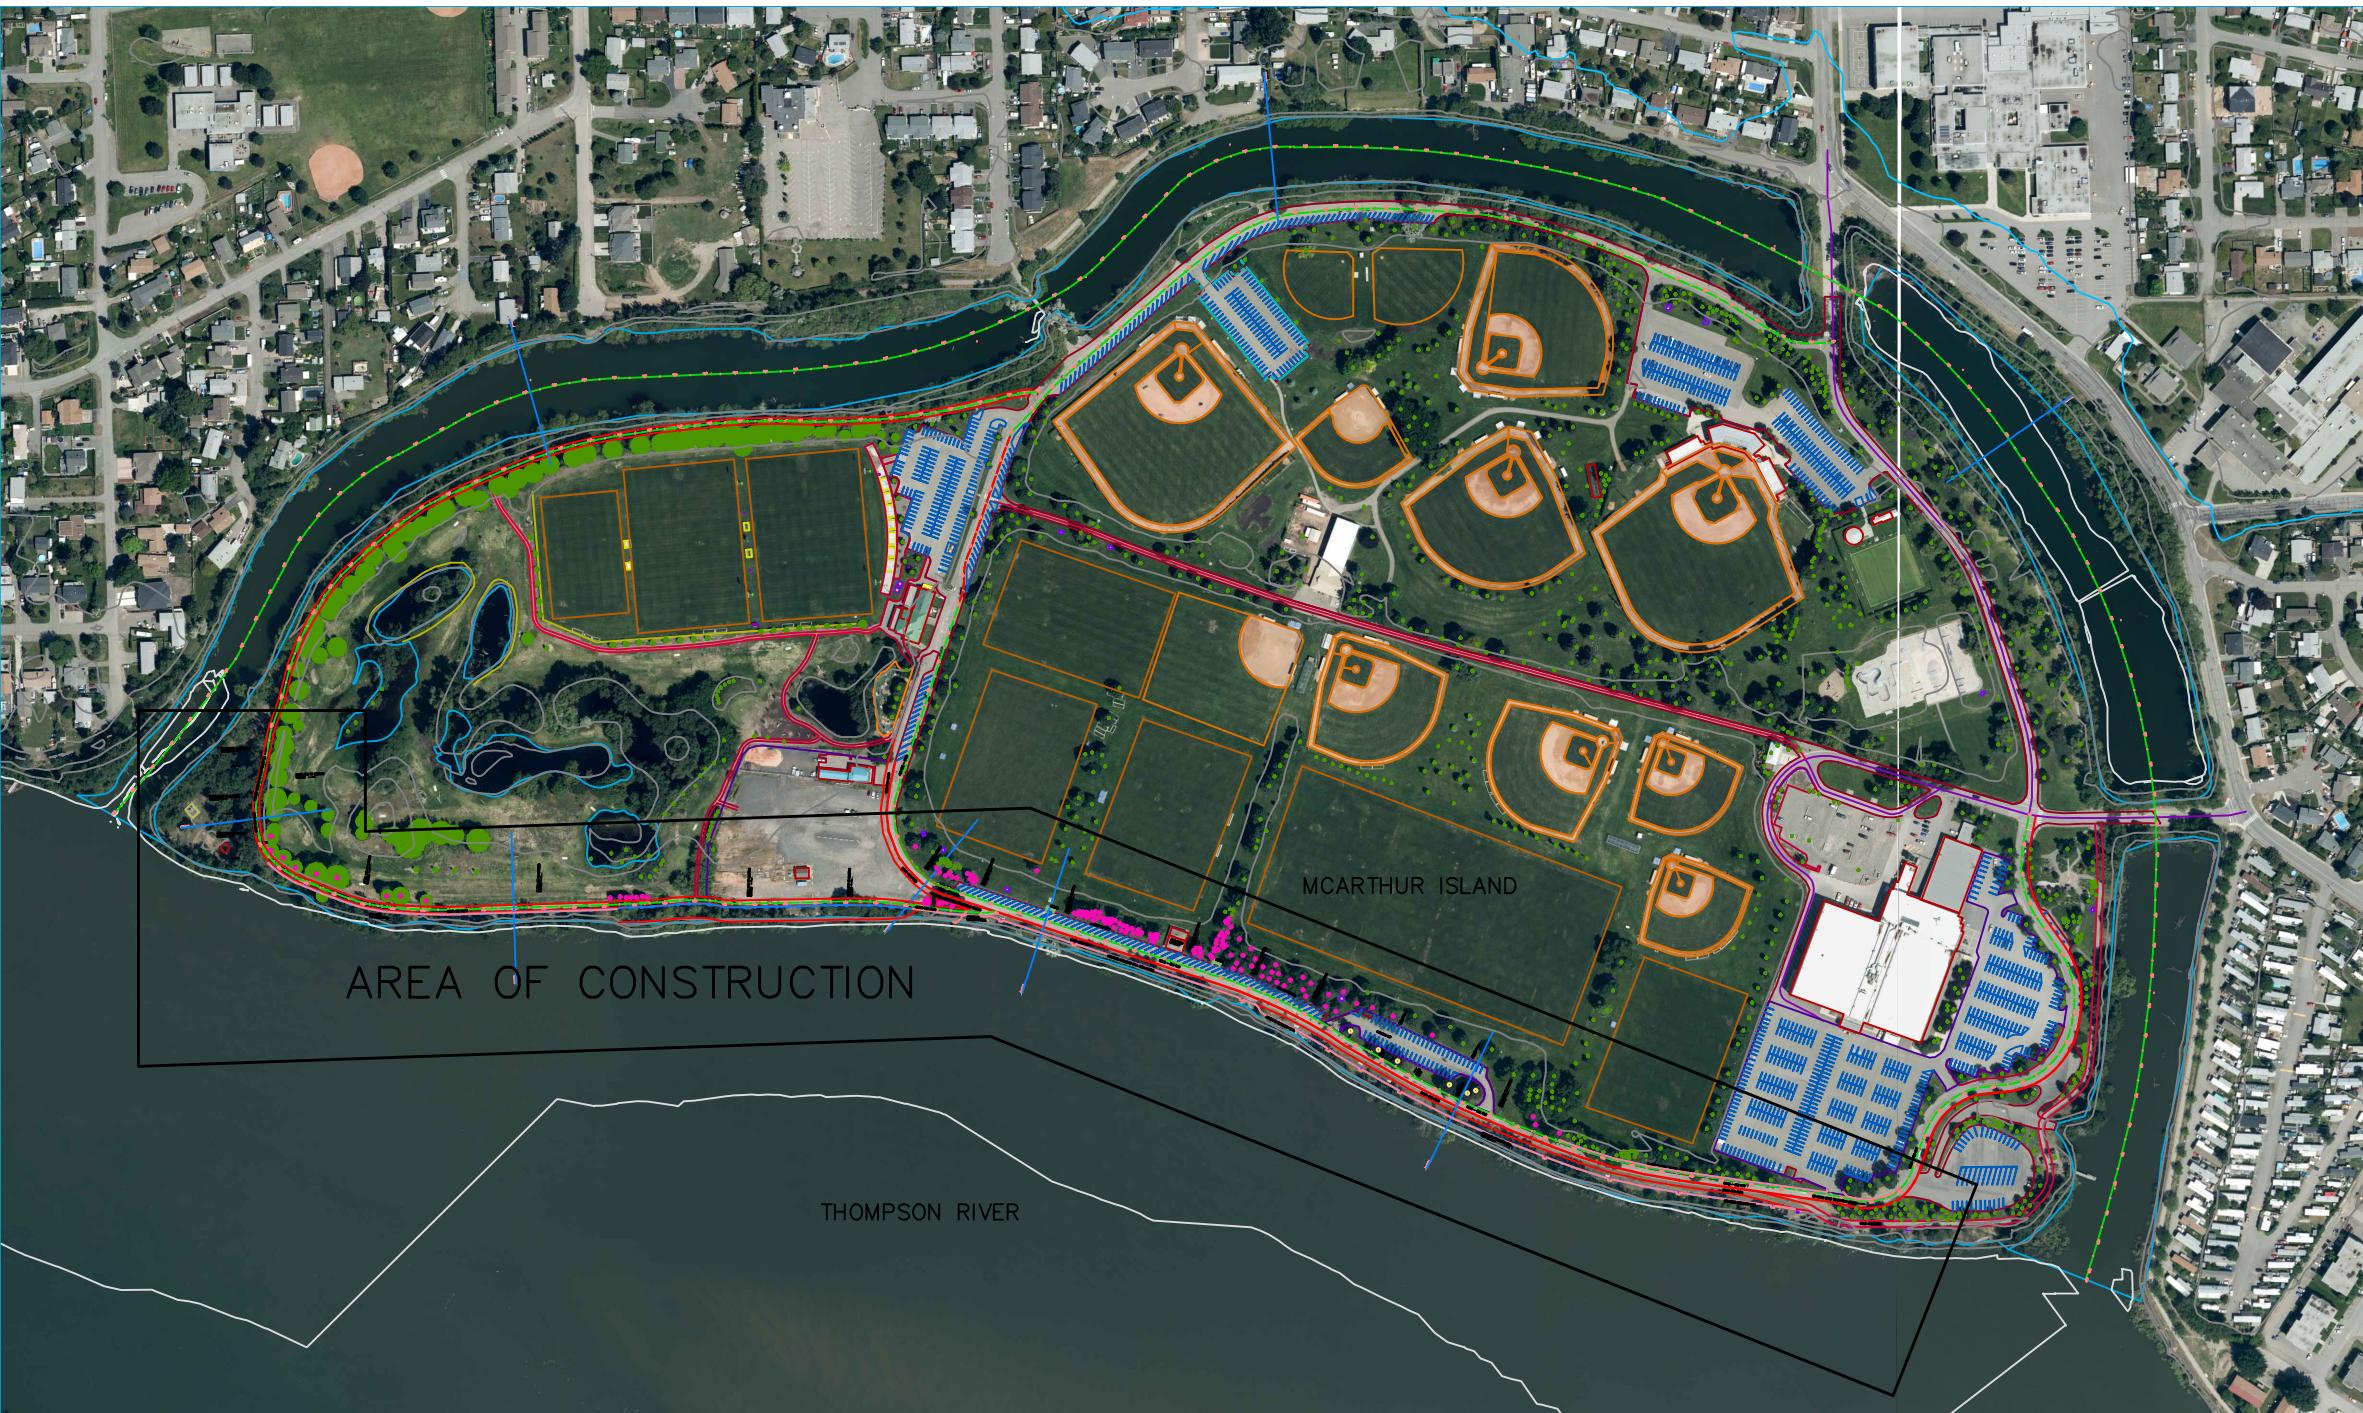
A1

MCARTHUR ISLAND FLOOD PROTECTION REDESIGN

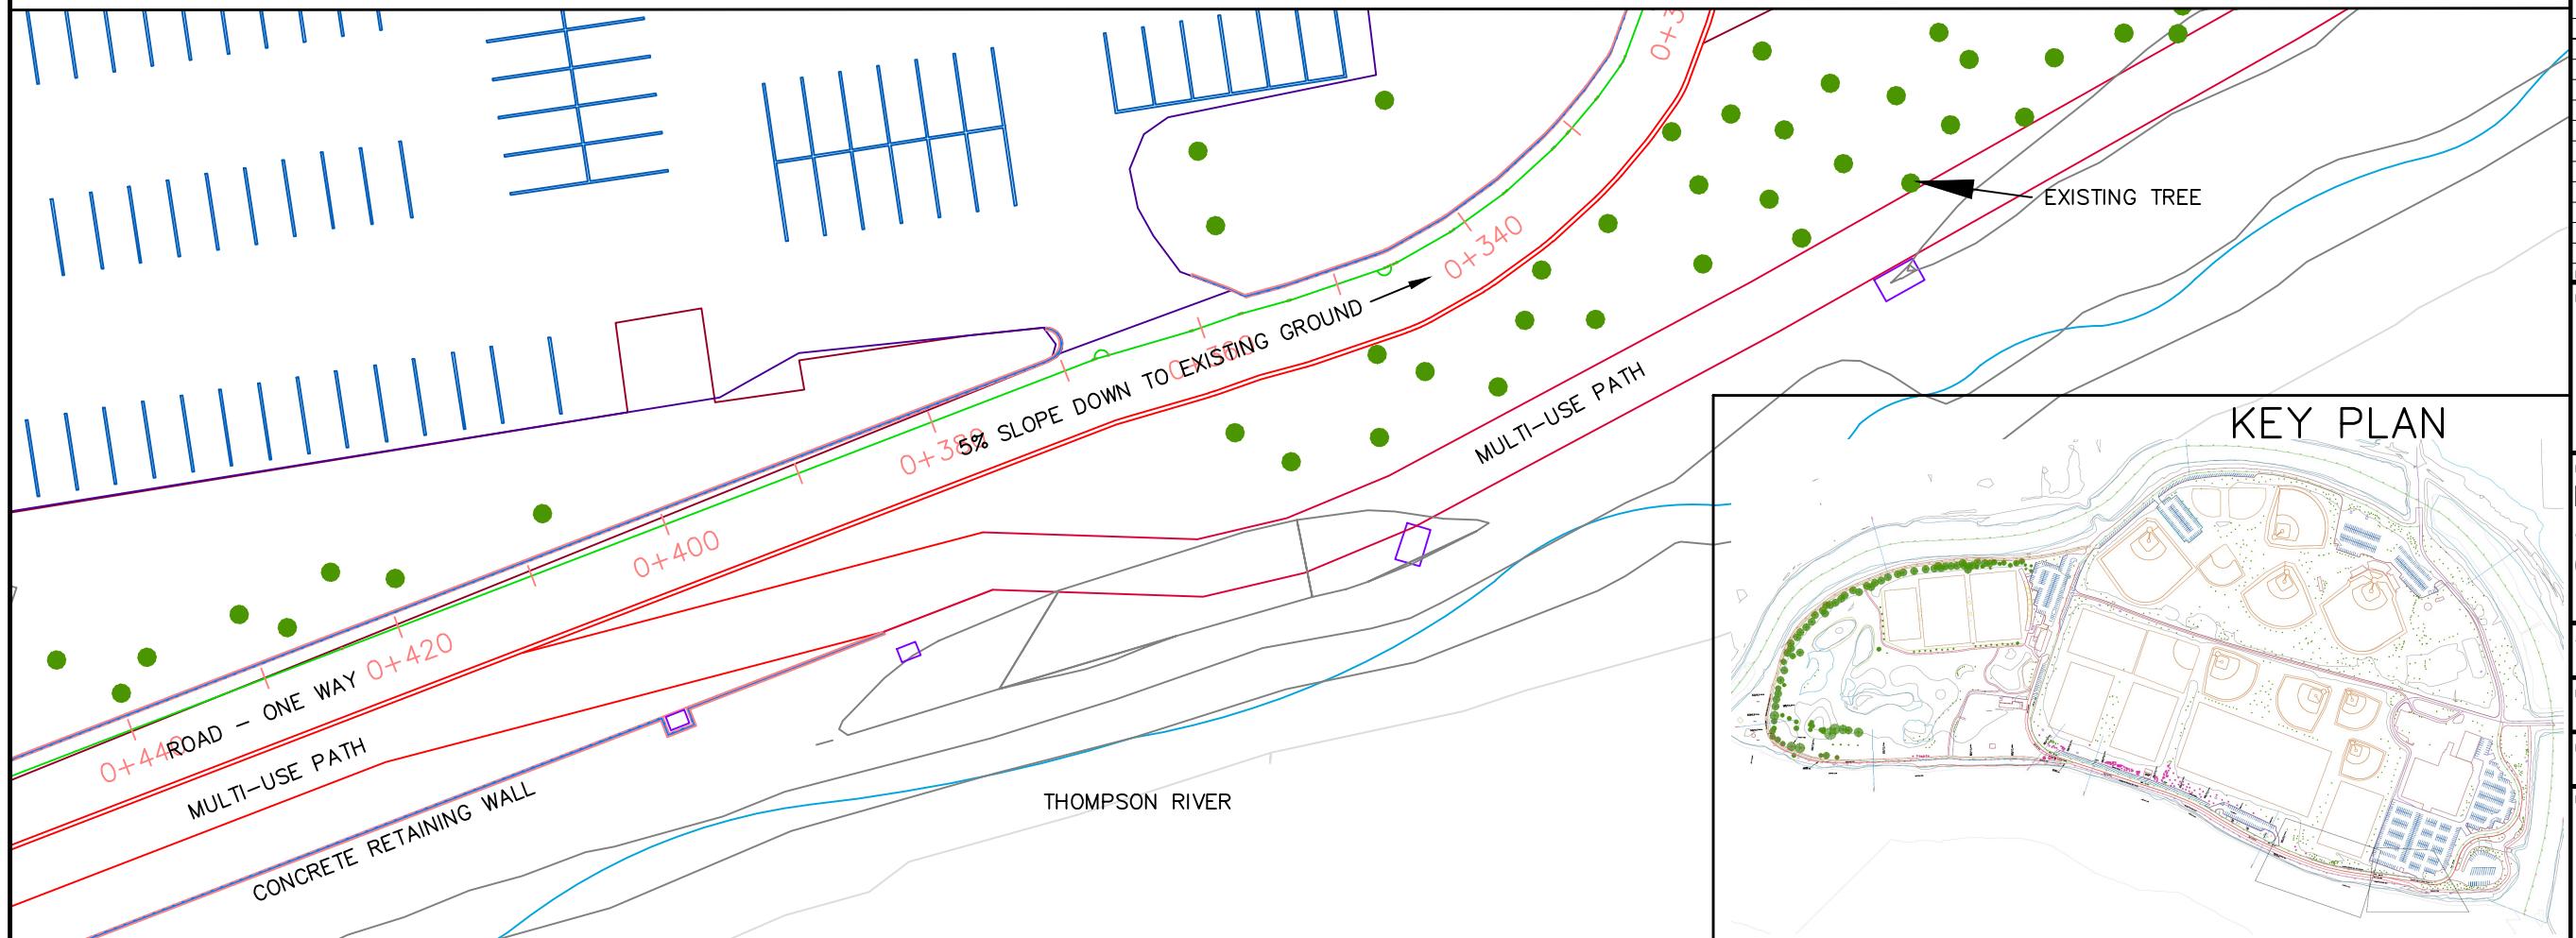
A5

No.	Revision	Date	By
PROJECT NAME			
MCARTHUR			
ISLAND FLOOD			
PROTECTION			
DRAWING TITLE			
ROADWAY			
STATIONS			
0+330 - 0+600			
SCALE	1:500		
DRAWN BY	H. CLARK	CHECKED	M. MARSHALL
DATE	11 NOV 2021	JOB NO.	2021-001
DRAWING NO.

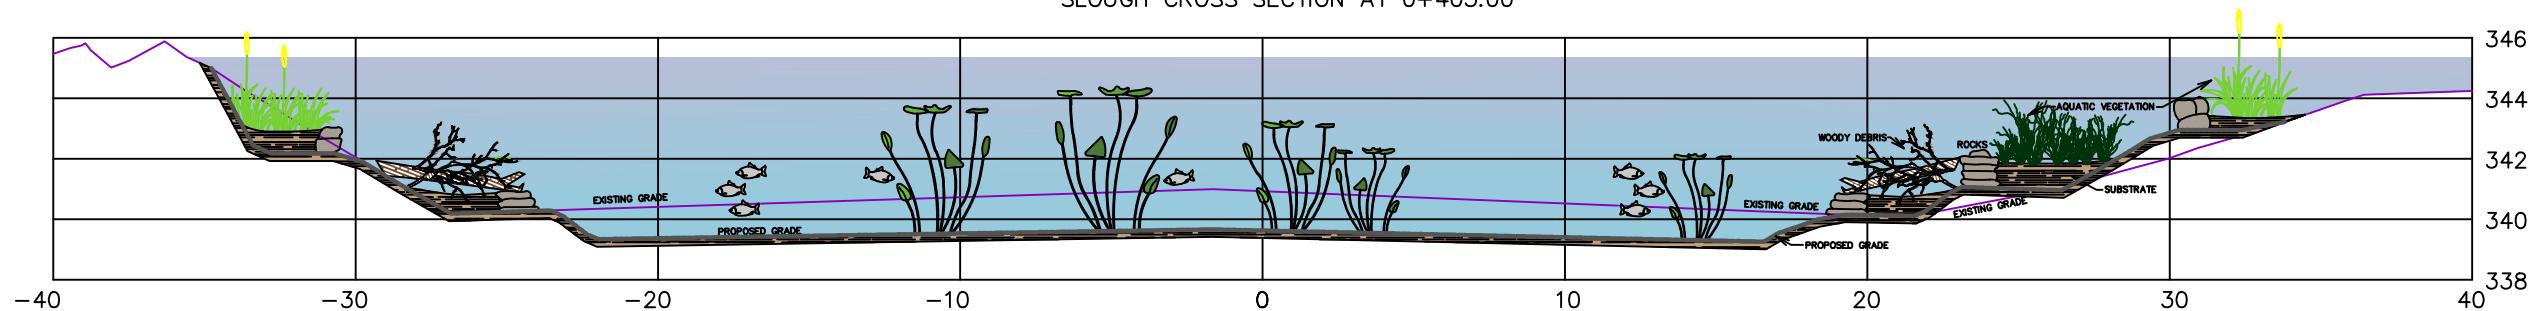
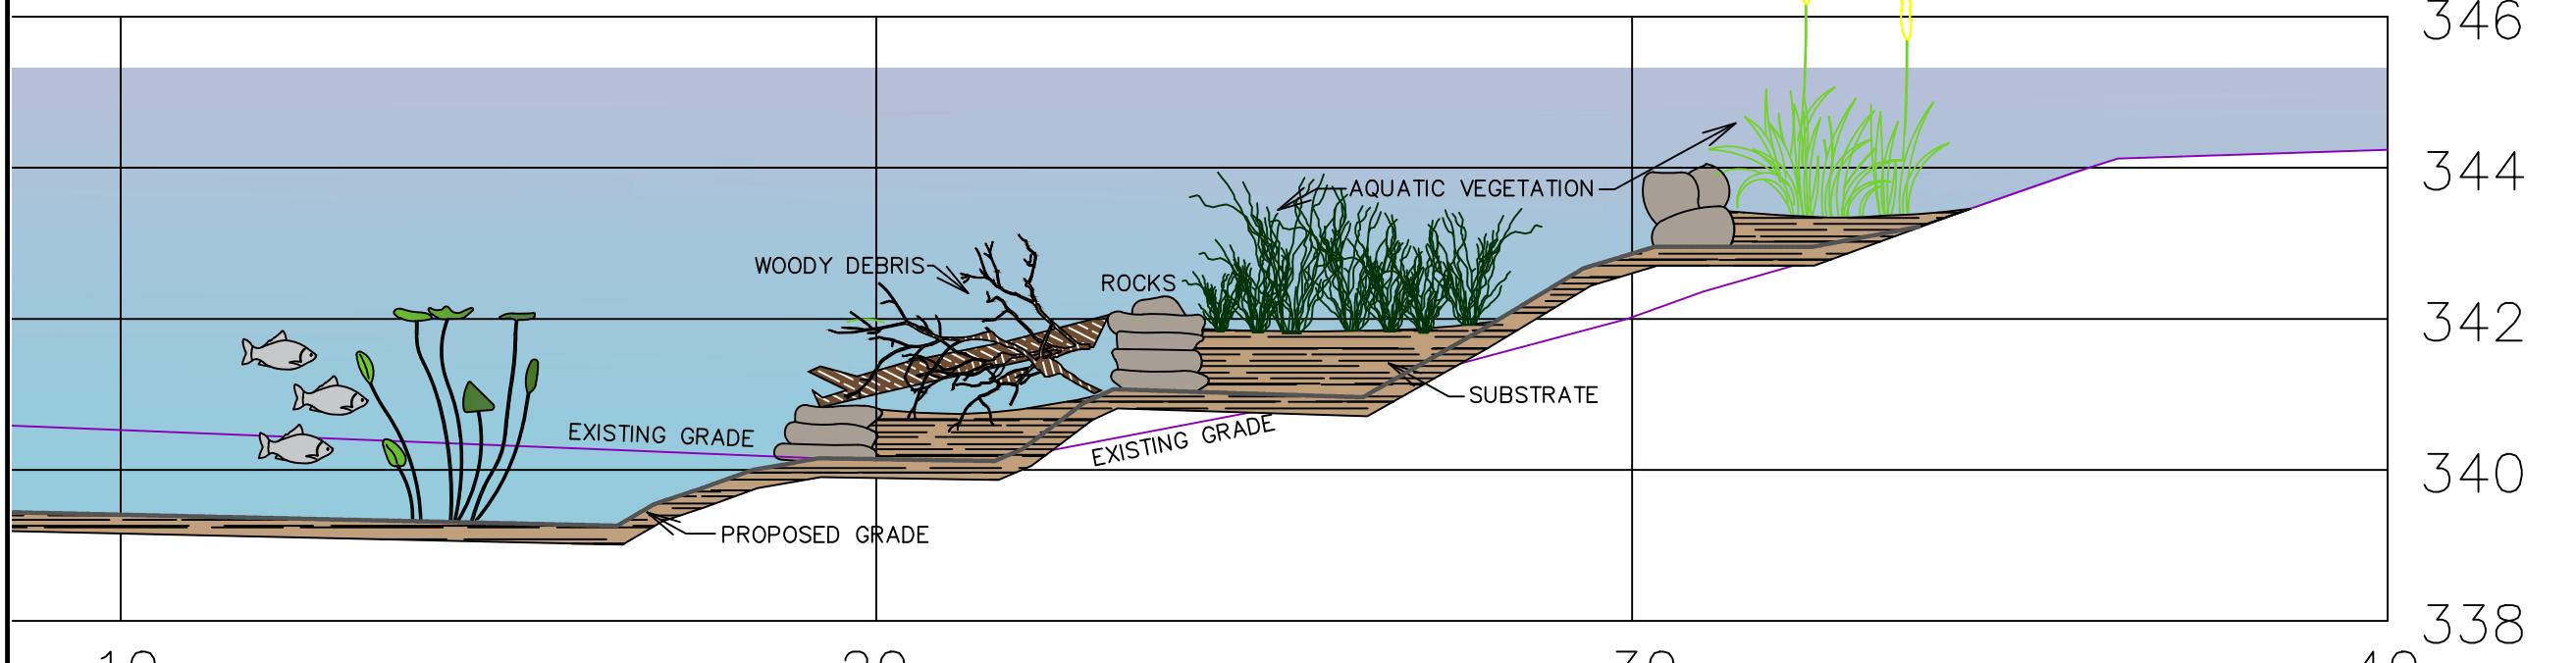
SLOUGH
CROSS
SECTION AND
DETAIL

SLOUGH CROSS SECTION AT 0+405.00

DETAIL OF SLOUGH CROSS SECTION

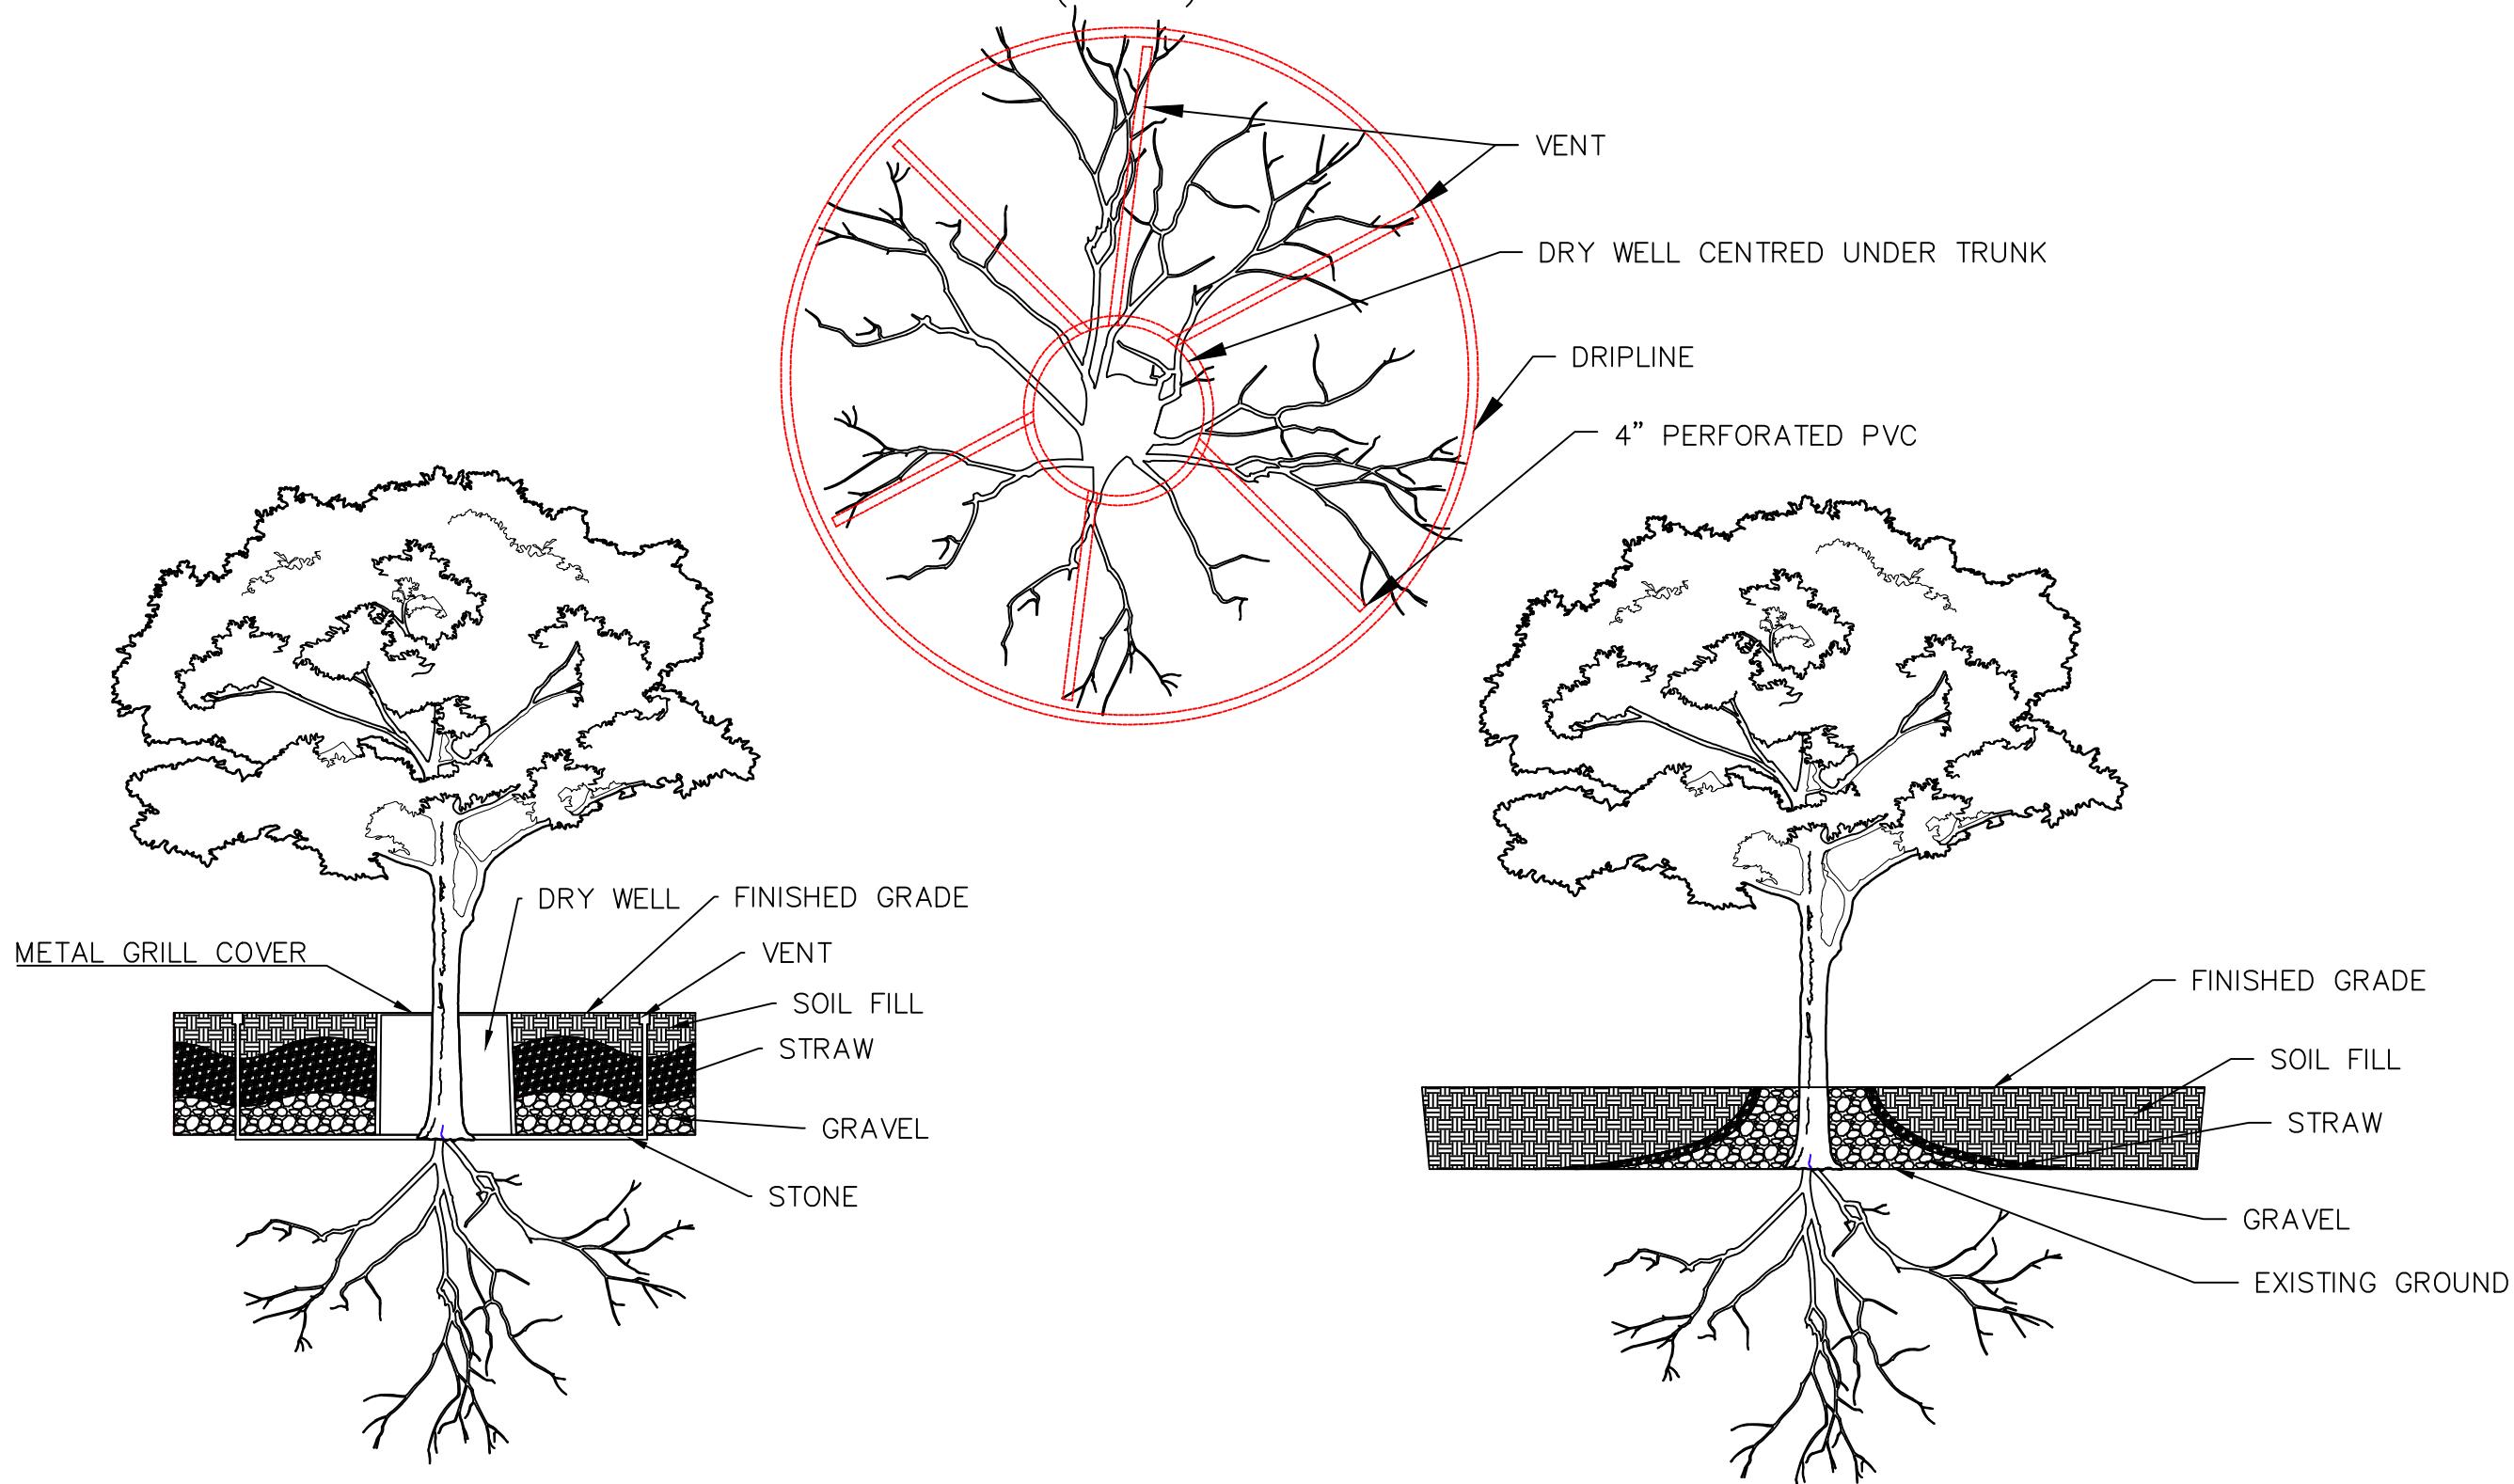
No.	Revision	Date	By
PROJECT NAME			
MCARTHUR ISLAND FLOOD PROTECTION			
DRAWING TITLE			
TREE DETAILS			
SCALE			
NTS			
DRAWN BY	H. CLARK	CHECKED	M. MARSHALL
DATE	11 NOV 2021	JOB NO.	2021-001
DRAWING NO.

WELL AND DRAINAGE DETAIL – PLAN VIEW (NTS)

PROCEDURE FOR GRADE INCREASE
OF 0.6M OR MORE (NTS)

PROCEDURE FOR GRADE INCREASE
OF 0.6M OR LESS (NTS)
